A Worker is Pinned Against the Rock Wall When his Tractor is Pushed by a Passing Vehicle

Serious Accident

Date: February 19, 2015

Category: Underground mine

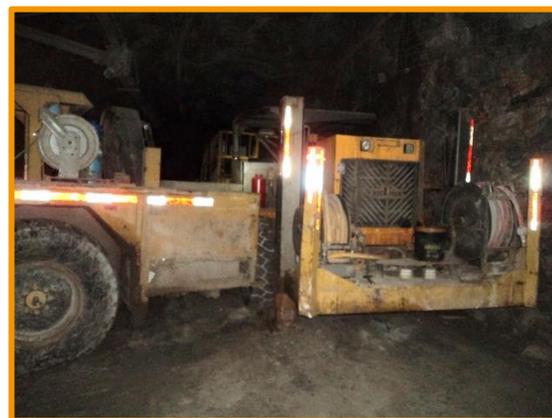
At around 10:40 p.m., a worker was repairing the ventilation doors of a chimney. His tractor, equipped with a mobile basket on the front, was parked at an angle in the entrance. The worker went in between the basket and the rock wall to solder the lower hinges. A maintenance miner driving a scissor lift tried to drive between the tractor and the rock wall. There was not enough space, and the scissor lift struck the tractor, pushing it. The tractor moved suddenly, and the crouching worker was pinned against the wall by the basket. The worker suffered a pelvic fracture.

- The driver of the scissor lift tried to drive through the traffic lane when it was more than 50% obstructed.
- The working area was not set off and no physical obstacle was put up while the traffic lane was partially obstructed.
- The tractor's jacks were not deployed and there were no wheel chocks in place.

- Draw up a procedure on the obligation to bar traffic lanes using a clear and effective visual signal (e.g., tape, rope, etc.), and the obligation to obtain verbal authorization before driving through a traffic lane that is obstructed.
- Standardize the equipment used to bar traffic lanes and ensure that every vehicle liable to regularly obstruct traffic lanes has this equipment.
- Add the inspection of traffic lanes, traffic lane obstructions and barriers to the "carte de travail."
- Inform the relevant personnel about the procedure and train supervisors on the application of the changes.
- Design new developments in such a way that ventilation doors, main fans and other equipment can be maintained with no risk of collisions with vehicles in main roadways or in traffic lanes.
