## Two truck drivers die buried by major landslide in a quarry

### Fatal Accident

**Date:** January 29, 2013

**Category:** Quarry

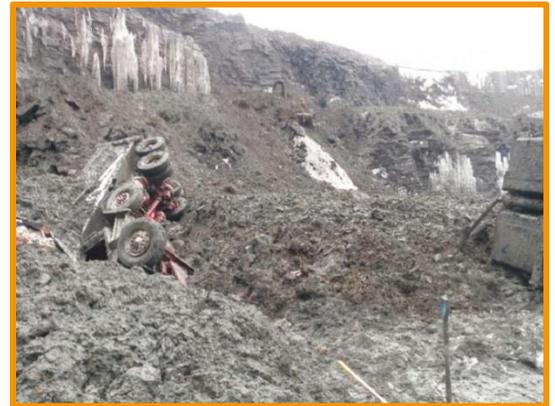
Photo source: MTQ

A hydraulic shovel operator was excavating on the edge of the quarry in order to relocate the haul road. While he was digging and loading two trucks with overburden, a major landslide occurred, burying the three workers and their equipment at the bottom of the quarry. Despite his injuries, the hydraulic shovel operator managed to get out of his machine and reach safety. The two truck drivers were found buried two days later.

- Excavation work done on a site that was susceptible to landslides triggered the movement of earth that buried two truck drivers and a hydraulic shovel operator at the bottom of the quarry.
- The planning and supervision of the quarry expansion were inadequate, specifically because expansion work was being performed when the impact on soil stability was unknown.

**Obtain the following three documents before performing excavation work in an open-pit mine less than 100 metres from a body of water or loose soil that may liquefy:**

- Engineer's plans and specifications
- An investigation of the properties of the rock mass to be excavated
- An investigation of hydrogeological conditions

**Analyze the risks associated with the nature of the soil by means of a geotechnical investigation and a statement from an engineer on the excavation method**
