## Worker seriously injured from being squeezed between two vehicles

### Serious Accident

**Date:** August 10, 2014  
**Category:** Underground mine  
**Task:** Loading materials  
**Position:** Mechanic

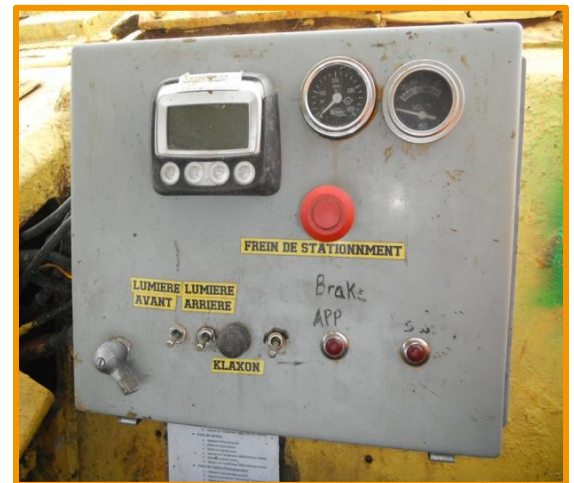
On August 10, at about 1:50 a.m., an operator was positioning his loader on a slope near a tractor to transfer explosives onto it. He put the clutch in neutral, put on the parking brake, and turned off the engine before getting off the loader to install the wheel blocks. Being unfamiliar with this loader, his tests did not allow him to see that the brakes on the driveline were worn, as the brakes released only intermittently. A mechanic was positioned between the two vehicles and was transferring the explosives to the tractor. Just at that moment, the loader shifted and squeezed him between the two vehicles. He suffered multiple fractures.

- Prior to the incident, the parking brake repair was not effective, as the brake problem diagnosis was incorrect.
- The brakes on the driveline of the loader were defective.
- A worker was positioned between the two vehicles before the loader was secured.
- Parking and brake testing procedures were not observed.
- The workers did not know the brake testing procedure for this type of loader.

- Provide training for workers who are likely to use this type of vehicle on the brake testing procedure for this type of loader.
- Update the training on equipment with the same braking system and provide it to workers and mechanics.
- Review the parking procedure for machines with all workers and supervisors.
